US Army Corps
of Engineers®
Engineer Research and
Development Center

Laboratory and Field Evaluation of In-Place Asphalt Recycling Technologies for Small Airfield Repair

June 2013

Final report

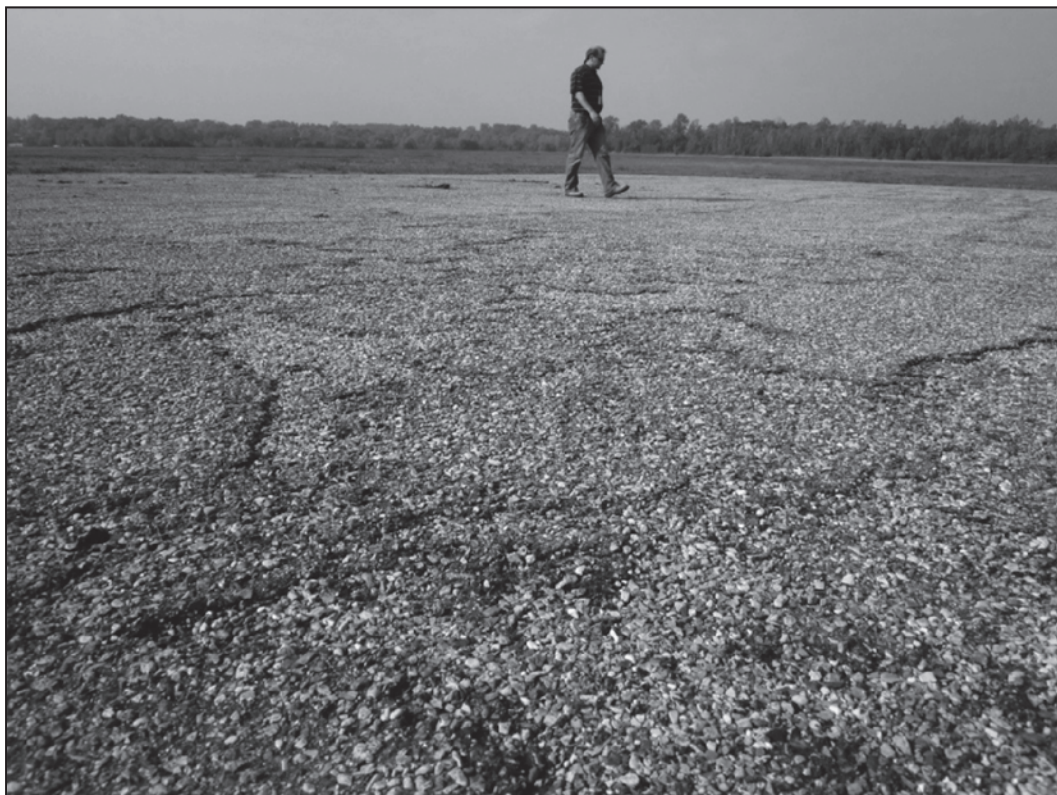
original asphalt binder PG was 67-22. A visual inspection of Test Site 1 revealed an oxidized and brittle pavement, with serious raveling and weathering issues. This condition made this test site a prime candidate for an asphalt recycling evaluation. Test Site 2 consisted of a newer pavement without critical distresses. Figure 5 shows the average aggregate gradation curve obtained for both RAP materials and the properties measured. Both gradations generally met the airfield specification gradation limits.

Figure 23. Existing surface conditions at Test Site 1.

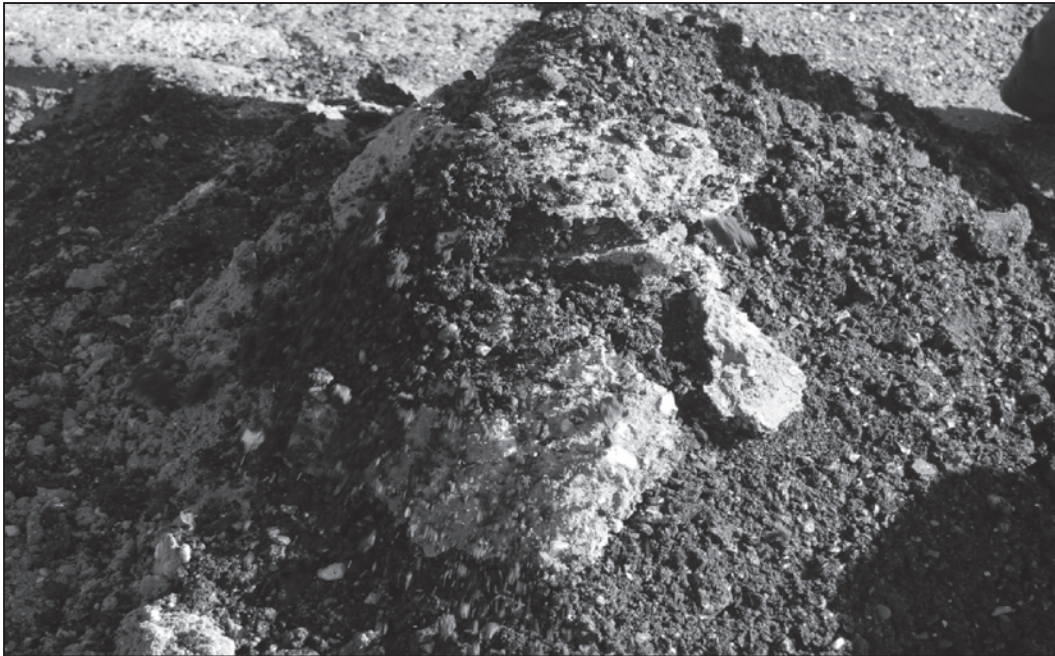
Figure 57. Disturbed base material mixed with excavated RAP.

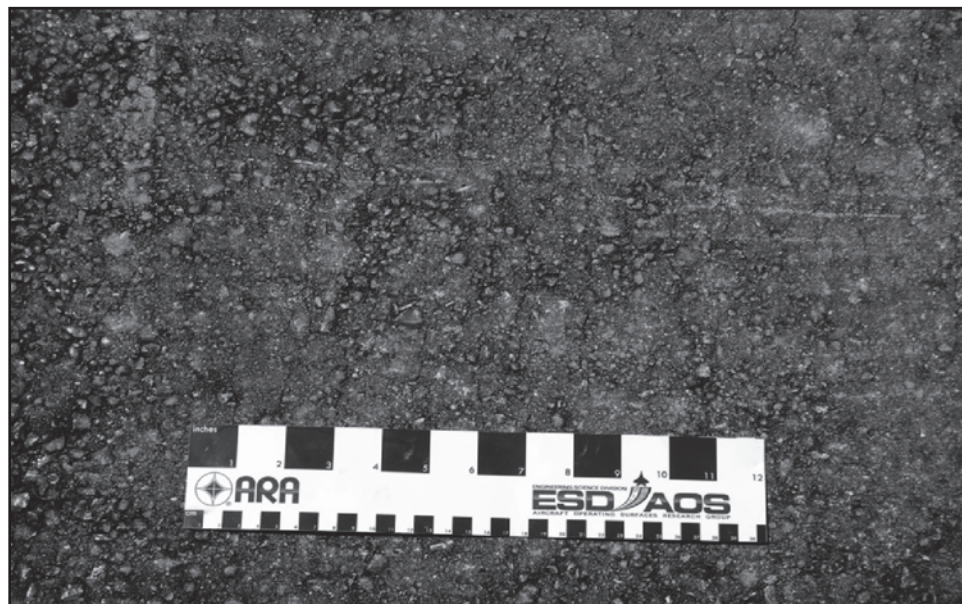
Figure 59. Surface cracking (PD-3).

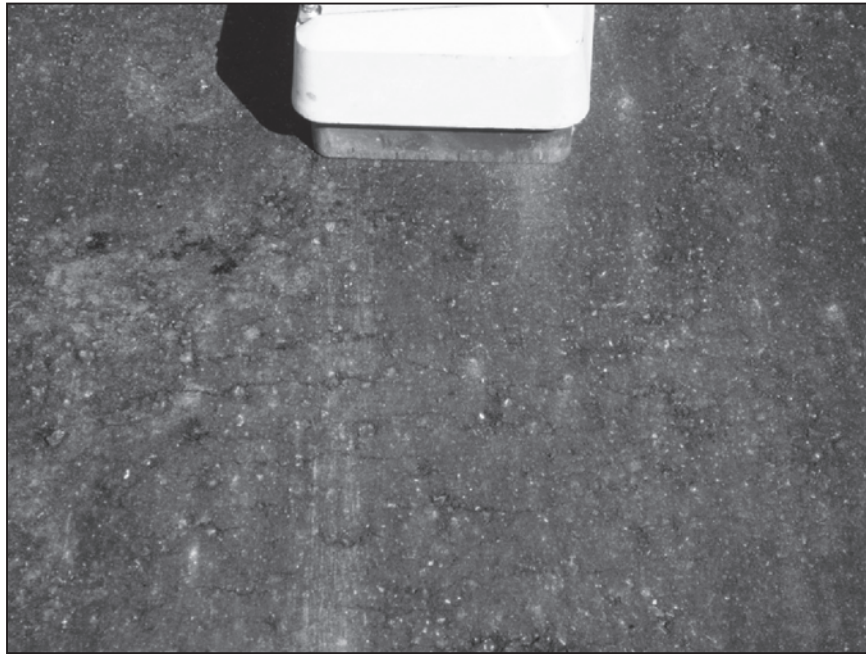
Figure 63. Post-compaction surface cracking (PHP-4).

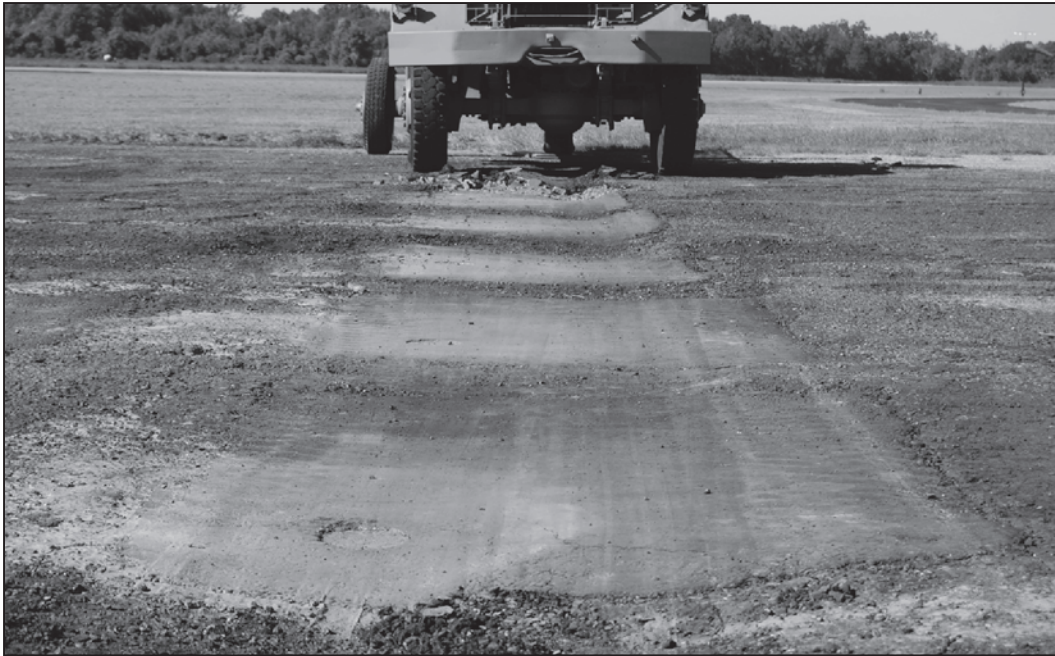
Figure 66. Full-depth repairs lane after traffic (front to back: FD-5, FD-4, FD-3, FD-2 and FD-1).

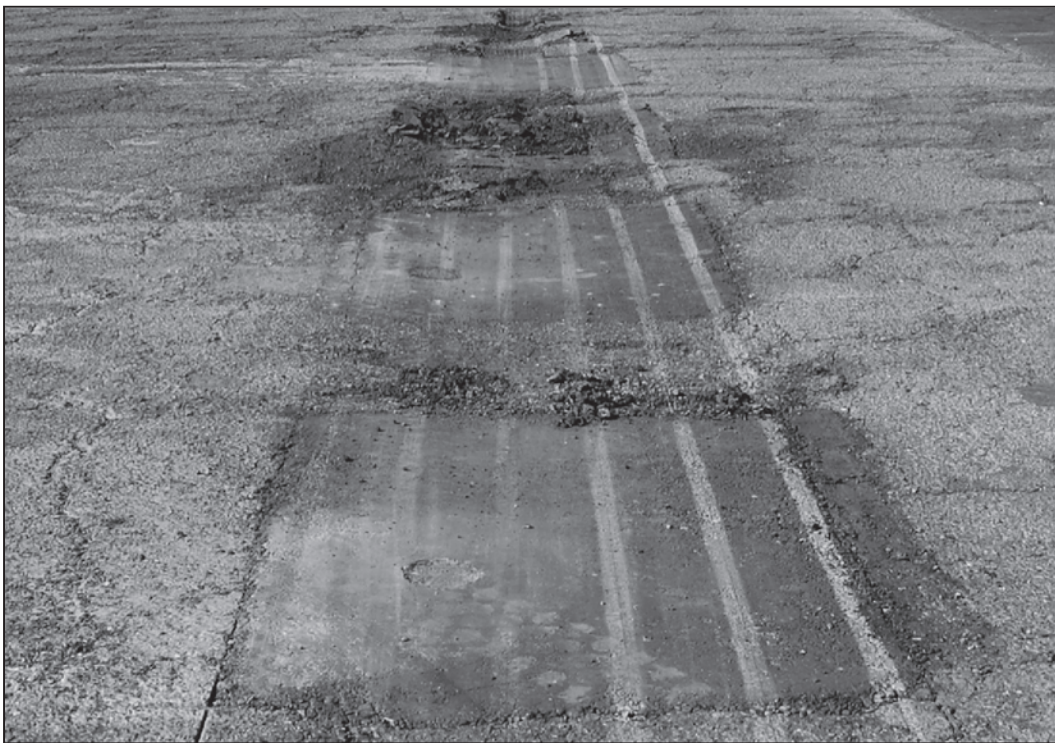
Figure 67. Partial-depth repairs lane after traffic (front to back: PD-4, PD-3, PD-2 and FD-1a).

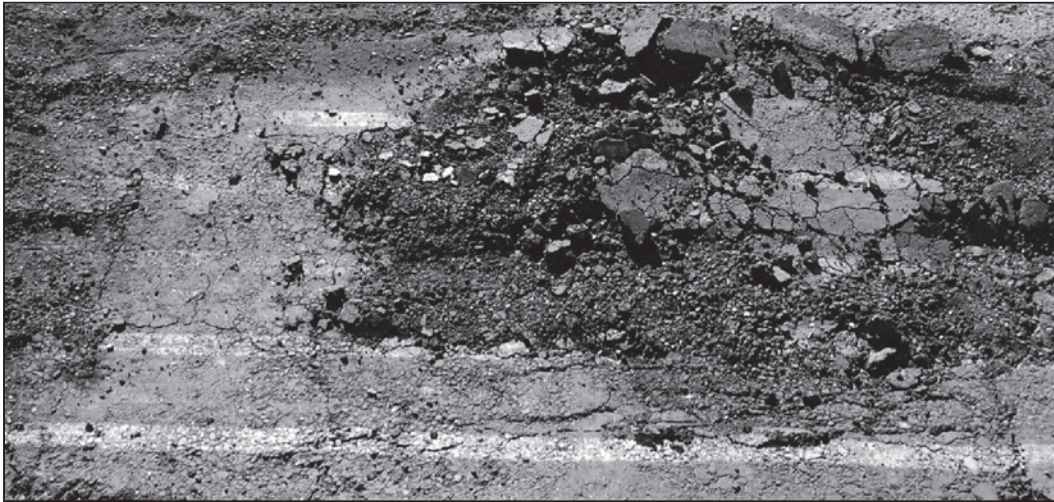
Figure 70. Repair PD-2 after traffic.

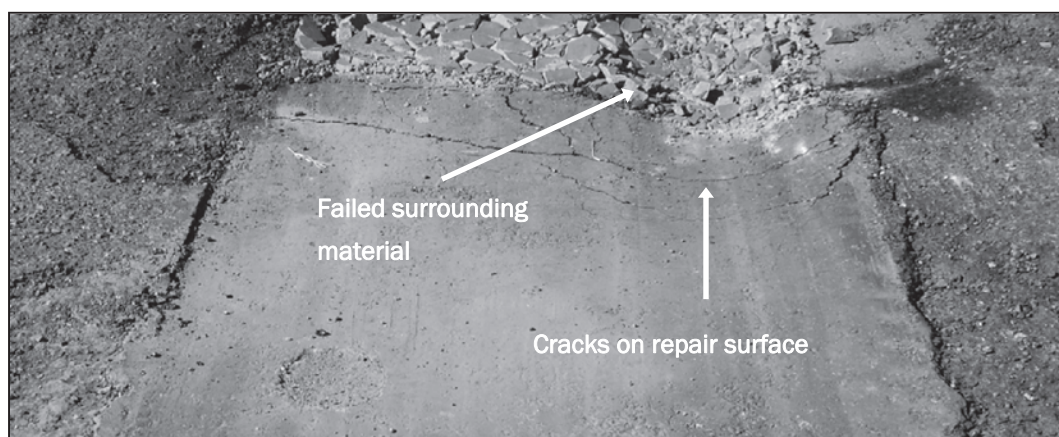
Repair entrance and exit areas relative to traffic direction showed cracking near the edges as shown in Figure 71. This was attributed to deformation of the surrounding asphalt material during traffic. The existing pavement did not provide enough confinement to prevent cracking and failure of the recycled asphalt material in these areas. A factor of failure in the Vicksburg Airport tests site was early subgrade failure and poor surrounding asphalt conditions.

Figure 71. Cracking on repair FD-1 caused by surrounding material failure.

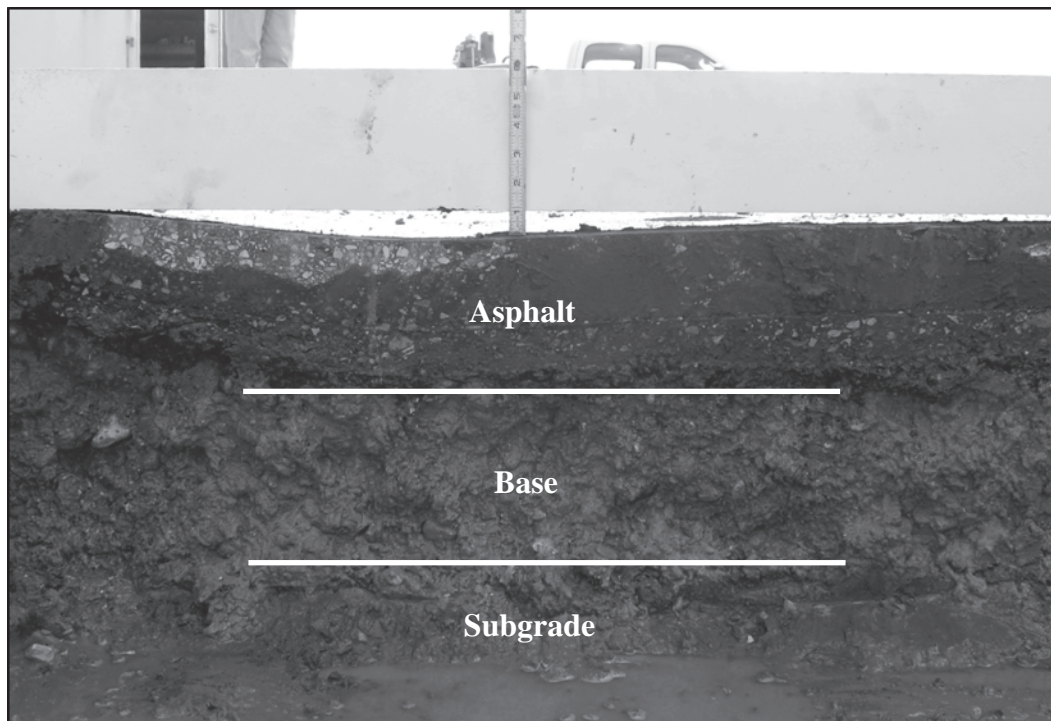
Figure 72. Repair FD-2 trenched cross-section view after failure.

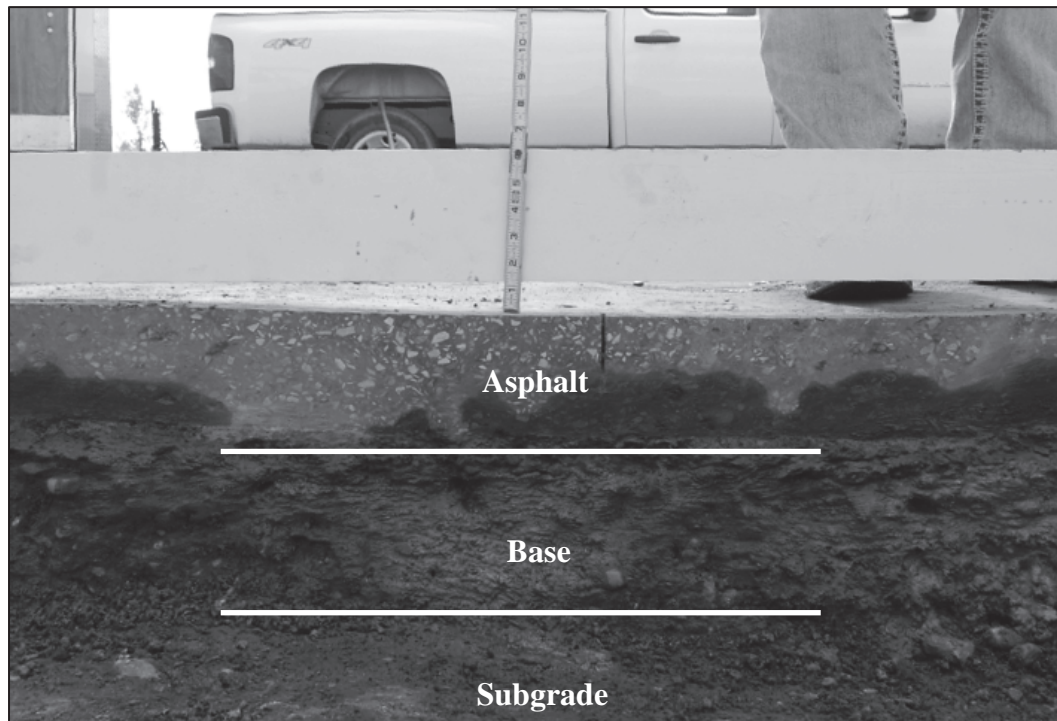
Figure 73. Repair FD-5 trenched cross-section view after failure.

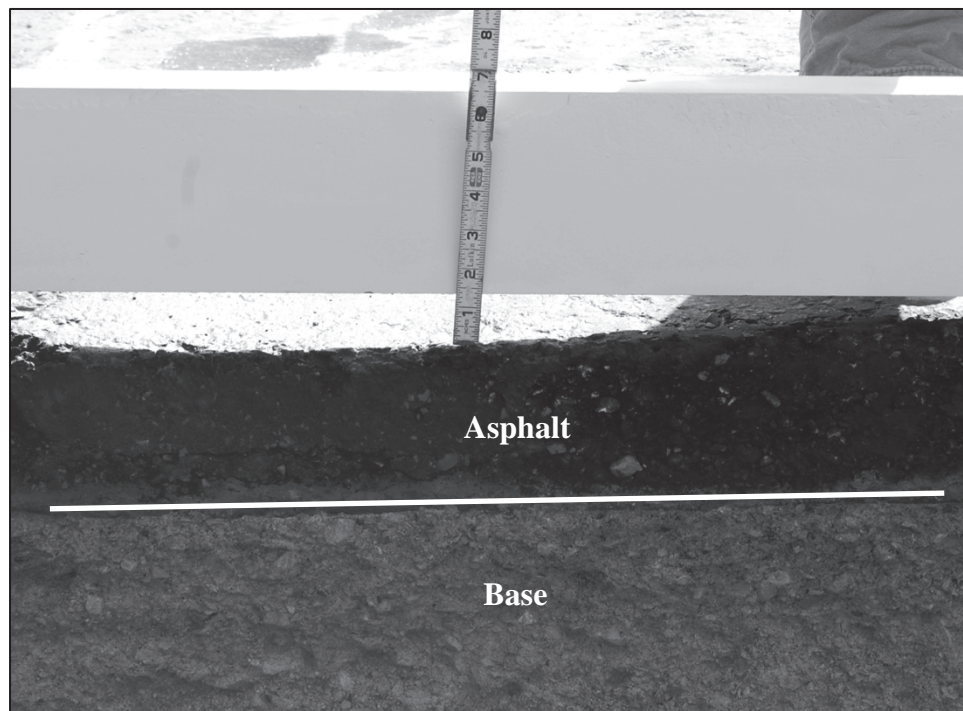
Figure 78. Repair PHP-4 trenched cross-section view post traffic.

PHP-4 exhibited the greatest rut depth of all four repairs conducted at Test Site 2. Trenching revealed loose material close to one edge (which could be expected for repair edges), but uncoated aggregate was also observed as

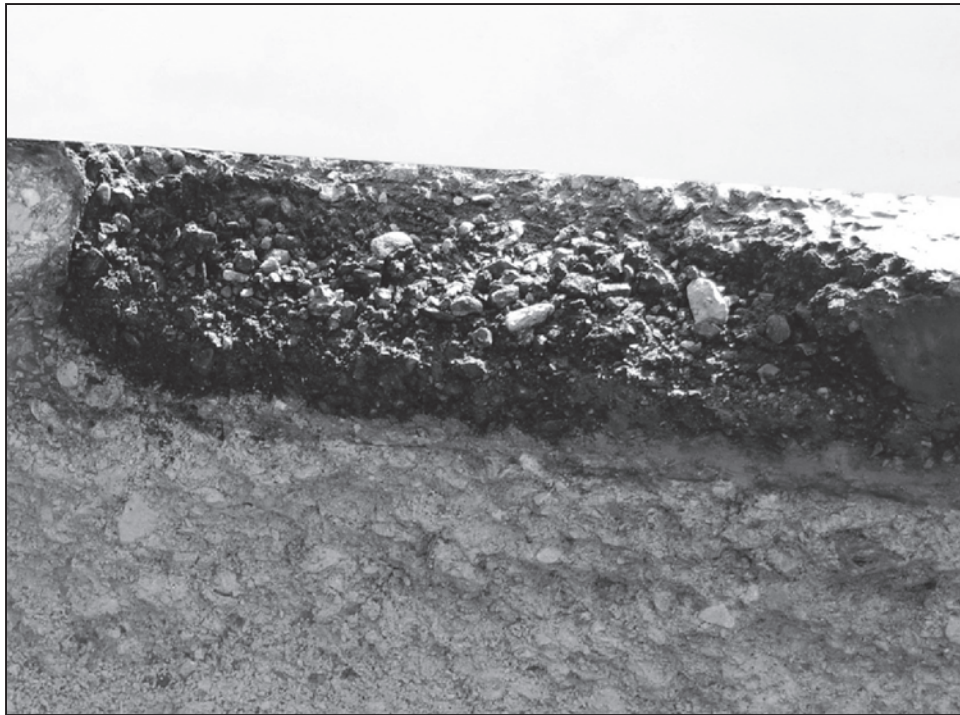
Figure 80. Loose recycled asphalt material after repair PHP-4 was trenched. (Note the uncoated aggregates).
