Infrared Joint Heater

AK Peninsula Highway: King Salmon
Naknek Pavement Preservation

AAPA November 26, 2014

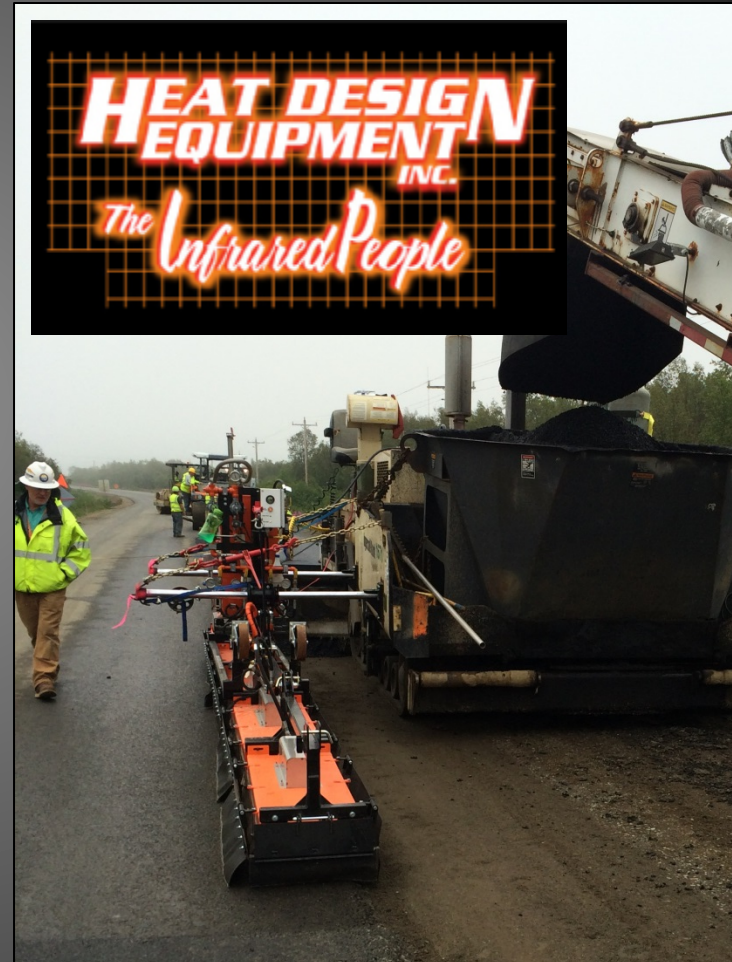
- Heat Design Equipment
 - JMH 500-PA – 20' 500,000 BTU
- 100% infrared heat
- Five ceramic cartridge heating elements
- Run pressure range from 5-40 psi
- Runs off of liquid propane tanks
- Two point attachment onto paver
- Adjustable paving width (manual)

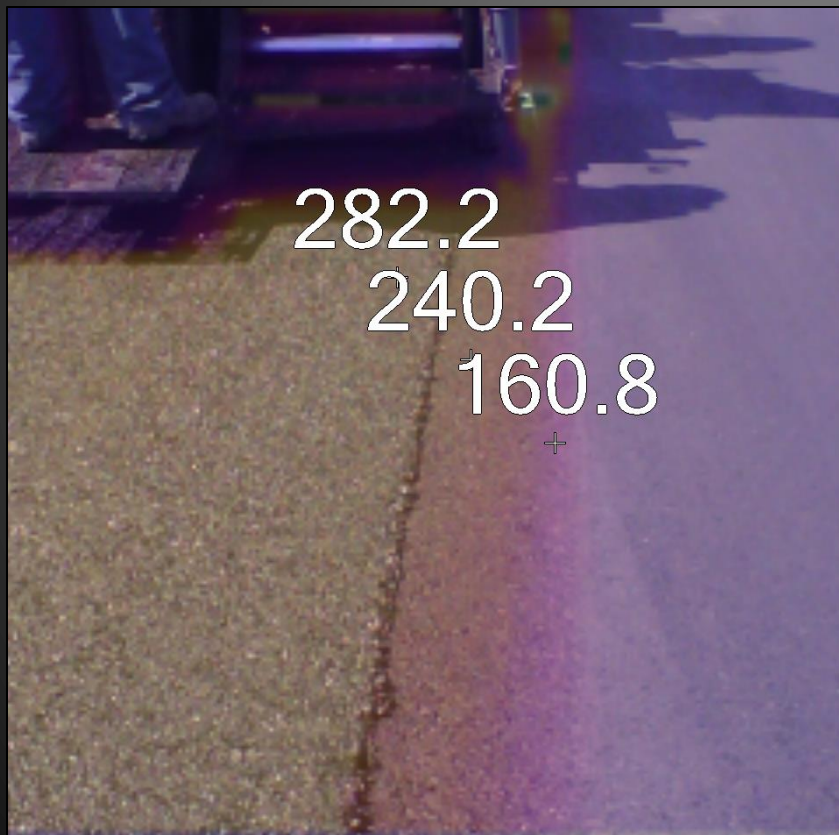
Temperature Results

- Measured with Fluke Thermal Imager

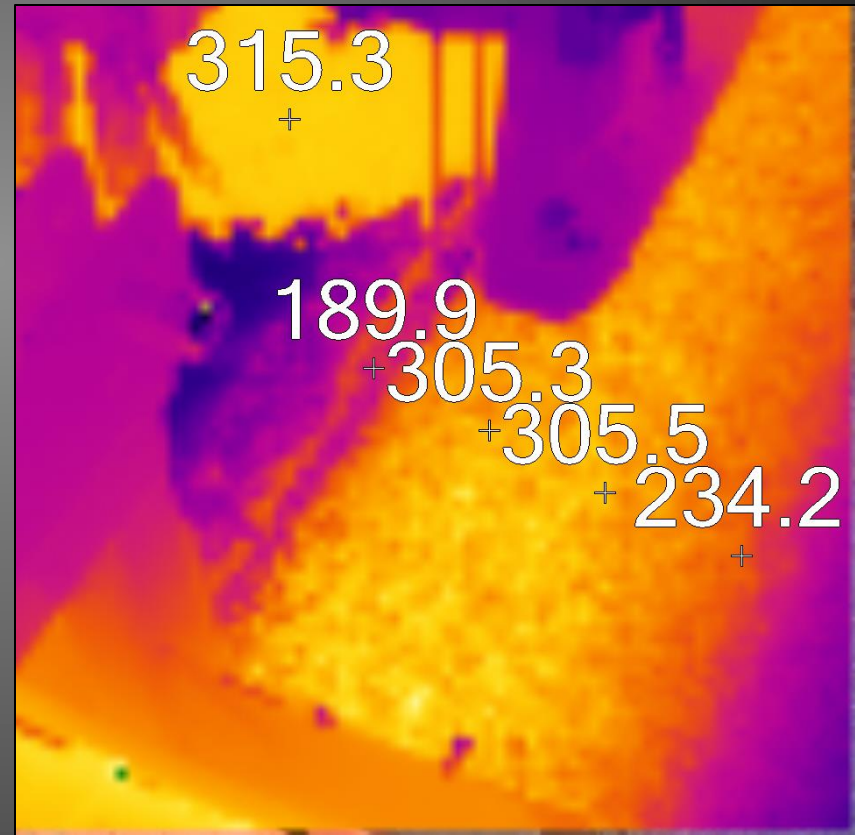
Temperature Results

- Measured with Fluke Thermal Imager

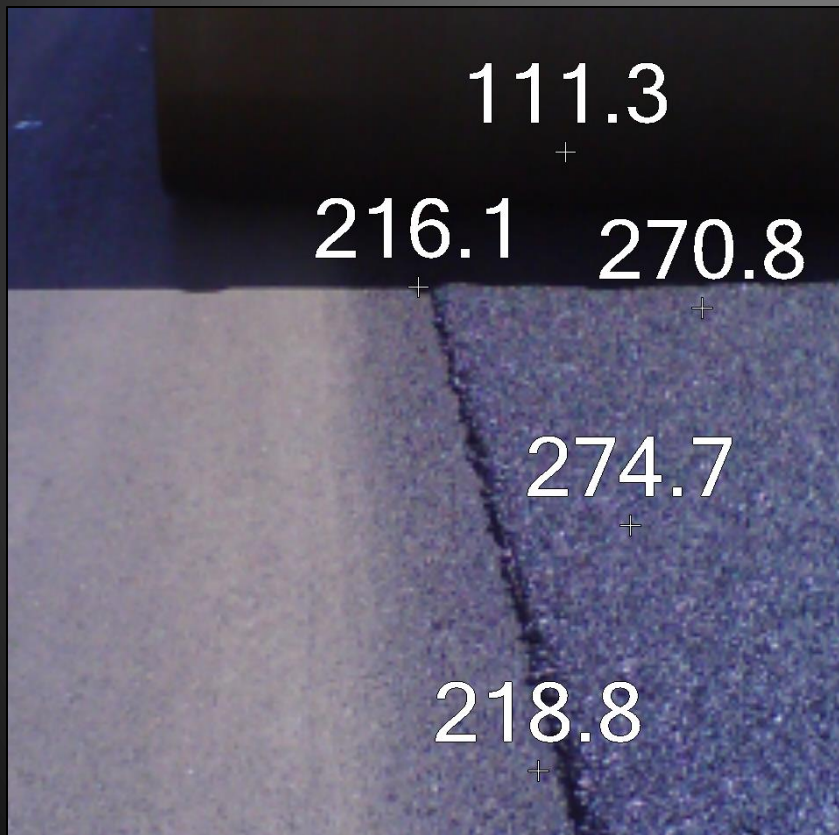
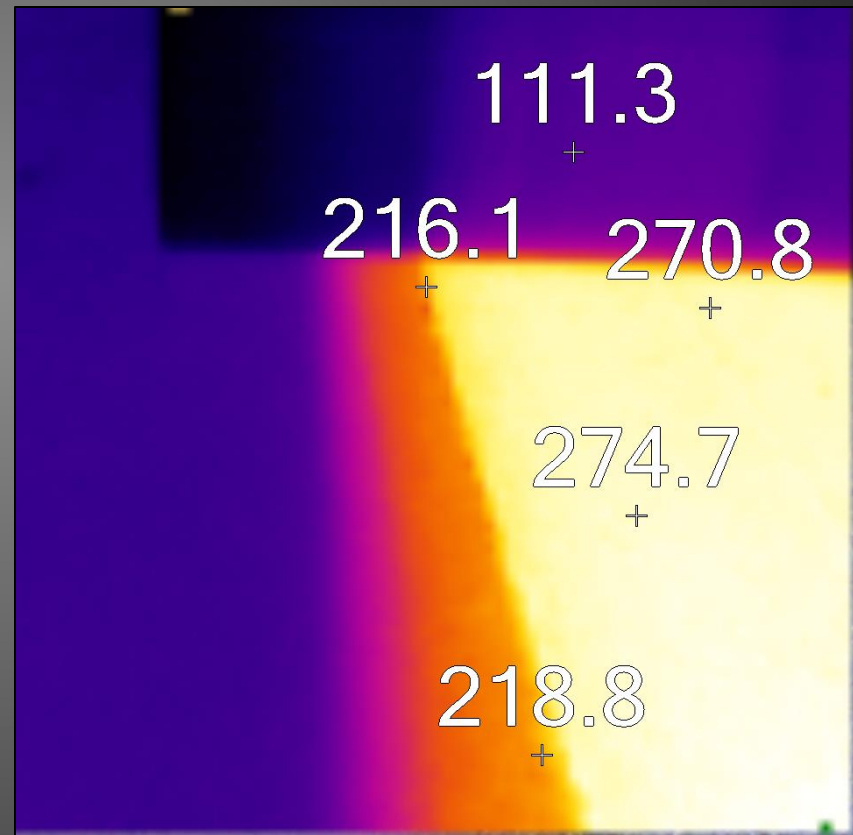
Temperature Results

- Measured with Fluke Thermal Imager
