US Army Corps
of Engineers®
Engineer Research and
Development Center

Laboratory and Field Evaluation of In-Place Asphalt Recycling Technologies for Small Airfield Repair

June 2013

Final report

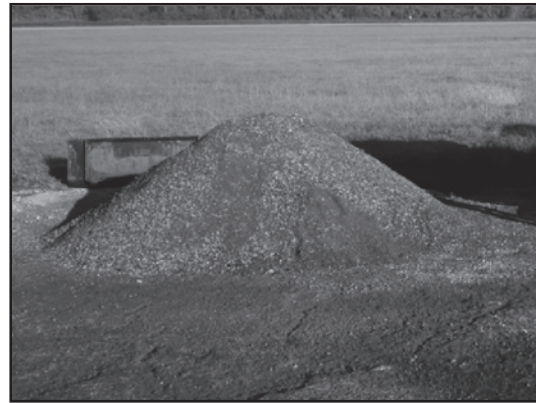
Figure 34. Spoil pile from site sweeping.

Due to the extensive raveling and loose aggregate on the apron surface, the entire site was swept using a skid steer-mounted broom attachment (Figure 33). The sweeping effort collected most of the loose material for offsite disposal. Removing debris from the pavement surface was important to prevent aggregate with little or no bonded asphalt from being included in the rejuvenation process. Uncoated aggregates in the final asphalt mix reduced the net asphalt content and ultimately decrease final performance of the repair. The removal of this debris also allowed the infrared heat to permeate directly into the existing asphalt layer, rather than being absorbed into the surface area of the loose aggregates. This increased overall heating efficiency and decreased time needed for sufficient heating. A photo of the loose material recovered from the repair site (Figure 34) illustrates the magnitude of site deterioration as well as the severity of overlay erosion and wear.

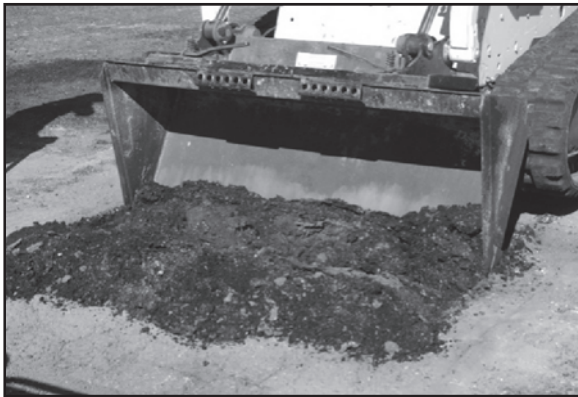
Figure 38. Skid steer-mounted bucket attachment.

Two separate methods for excavation of the existing asphalt material were tested. The initial method used a skid steer mounted general-purpose bucket to cut into the heated asphalt layer and remove the oxidized material. This method proved ineffective because it was difficult to maintain a constant depth across the repair area. It also produced large chunks of reclaimed asphalt, which were hard to break down in the drum mixer. Figure 38 shows the bucket being used to reclaim heated material from a repair area.

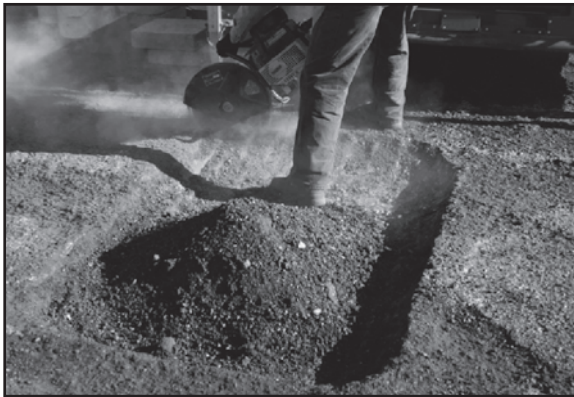
Figure 40. Squaring repair edge with saw.

Because the outer tines on the processor were designed using 45° cut angles, beveled edges were created along the repair length. Likewise, the spinning motion of the tiller tines also produced a radius at both ends. These effects can be identified in the repair cavity shown in Figure 40. A hand-held concrete saw was used around the repair perimeter to produce 90° vertical edges as visible in Figure 41.

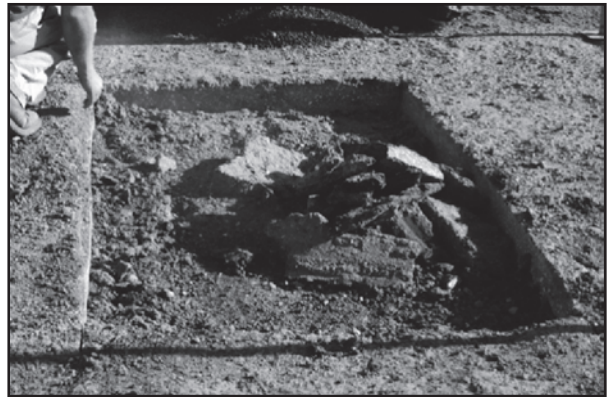
Figure 41. Squared edges and large chunks from saw cutting.

The saw cutting produced larger pieces of asphalt that could not be broken down effectively within the mixer during the rejuvenation process. Therefore, these large pieces were collected by hand in 5-gal buckets and weighed before being discarded. RAP material from the harvest stockpile or pelletized asphalt was then used in the rejuvenated batch (depending on individual repair protocol) to replace this lost volume.

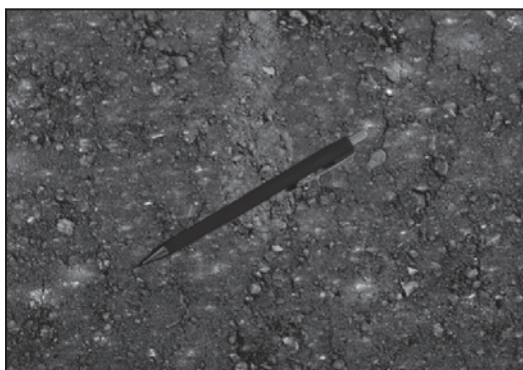
After compacting repair FD-2, surface cracking was abundant, and a considerable amount of uncoated aggregates were present. Figure 55 shows a scaled close-up of the final repair surface for FD-2. In an effort to mitigate the cracking and improve surface integrity, CRF was placed into a pressure

Figure 55. Post-compaction surface cracks (FD-2).

sprayer and applied lightly to the repair surface (Figure 56). The rejuvenator was allowed to penetrate the surface and become tacky before the roller was used to compact one final time. This effort was completed without vibration to prevent additional cracks from forming. When completed, the repair surface was again inspected visually, and the technique had sealed many of the visible cracks.

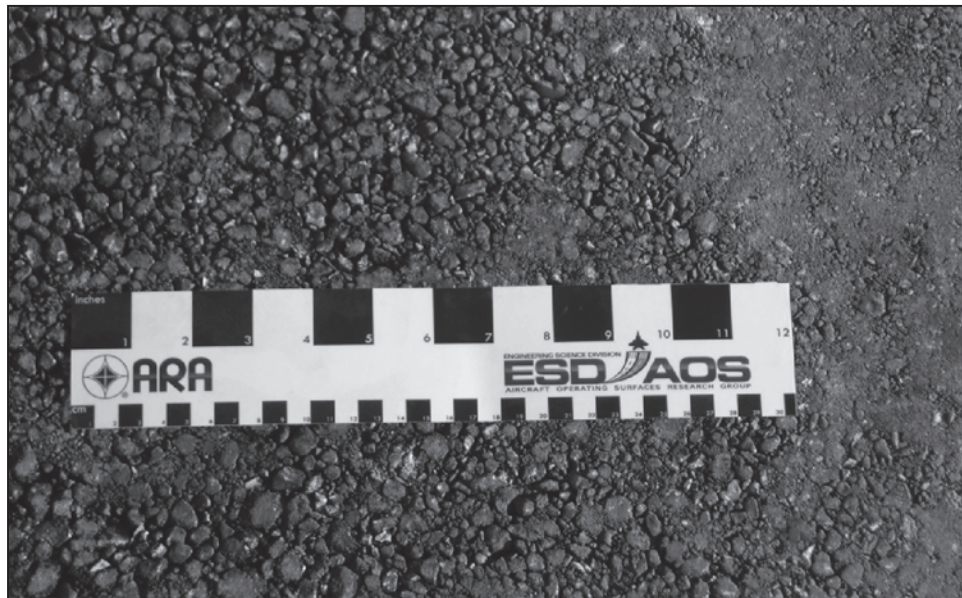
Table 13 describes the partial-depth repairs performed at Test Site 1. Repairs PD-2 and PD-3 were sprayed with CRF after compaction due to excessive amount of exposed aggregate material in PD-2 (Figure 58) and cracking on the surface of PD-3 (Figure 59). The compaction after spraying CRF was performed without vibration and seemed to mend the majority of surface cracks, but nuclear density readings indicated low densities.

Figure 58. Post-compaction repair surface (PD-2).

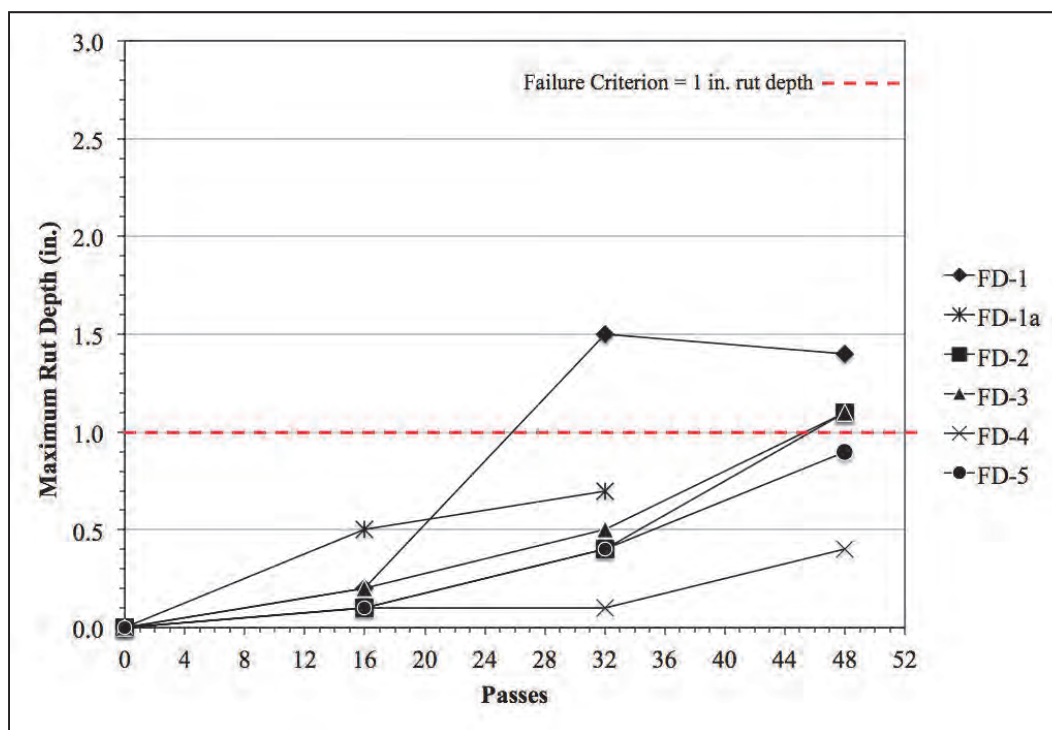
After the third coverage of the F-15 load cart (48 passes total), the measured rut depths in three of the full-depth repairs exceeded 1 in., and the surrounding asphalt rutted excessively. There was excessive loose material, which posed a tire hazard. To protect the load cart tire, traffic was discontinued on the full-depth repair lane. The partial-depth repairs failed after only two coverages of the F-15 load cart (32 passes total) with rut depth measurements exceeding 1 in. (except FD-1a). Figures 66 and 67 show an overview of all post-traffic full- and partial-depth repairs, respectively. No clear sign of tertiary deformation was observed on the surface of each repair. Rutting appeared to be more related to early sub-grade failure than to issues within the rejuvenated material, as predicted by the CBR and LEEP design criteria. The traffic data collected at this test site are summarized in Table 16. The rut depth data plots are compiled in Appendix A. The maximum rut depth per number of passes was plotted and is presented in Figure 68 for the full-depth repairs and Figure 69 for the partial-depth repairs. These plots were used to determine the number of passes-to-failure (1-in. rut depth) of each repair.

Figure 68. Rut depth measurements on full-depth repairs.

The number of passes that produced a 1-in. rut depth was determined from Figures 68 and 69. Although, the repairs at this test site did not meet the traffic requirements for sustainment operations (>3,500 passes of F-15 load cart) due to early failure of the subgrade, general observations may be used to compare performance between the different types of repair.

Based upon the rutting failure results obtained, the full-depth repairs performed better than the partial-depth repairs. The full-depth repairs where the propane heater was used (FD-4 and FD-5) performed better than most repairs using the electric heater (FD-1, FD-2, and FD-3). Some of the full-depth repairs where pelletized asphalt was used (FD-2 and FD-4) yielded equivalent or better results than where only rejuvenated RAP material was used (FD-1a, FD-3 and FD-5). However, repair FD-1 failed before FD-1a. One difference between these two repairs was that FD-1 had a small amount of pelletized asphalt, and seemingly the pelletized asphalt performed better than the RAP material. The better performance could also be attributed to the fact that FD-1 was compacted at a lower temperature, which caused a lower final density than that of FD-1a.

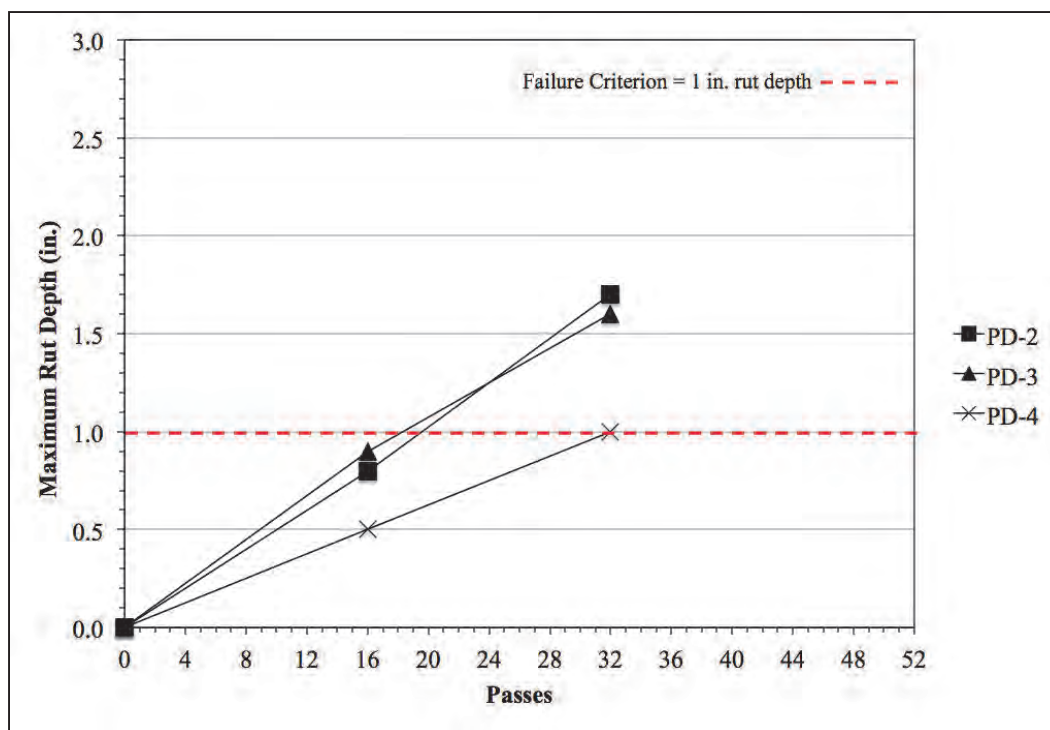
Figure 69. Rut depth measurements on partial-depth repairs.

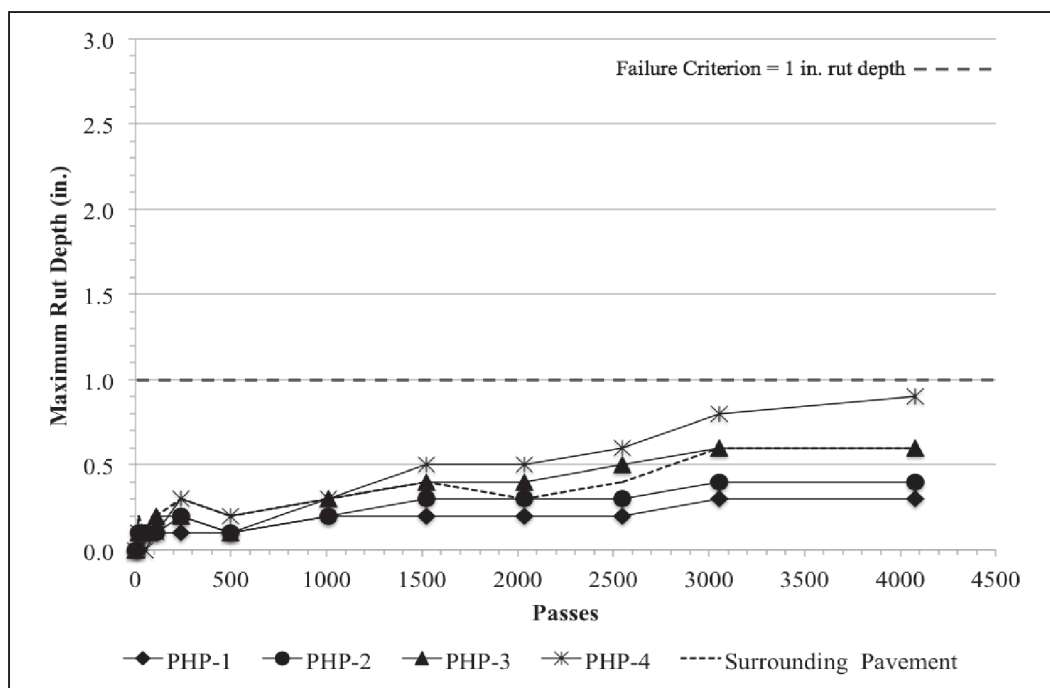
The traffic data were collected at different intervals to capture the rutting behavior of the repairs as trafficking progressed. The F-15 load cart was trafficked over the repairs to a maximum of 255 coverages (4,080 passes), and none of the repairs experienced rut depth failure of 1 in. or greater. Traffic data collected at this test site are summarized in Table 17 and presented in Figure 74.

Figure 74. Rut depth measurements on repairs at Test Site 2.

The fact that all the repairs installed and tested at Test Site 2 passed the sustainment repair criteria showed that repairs completed using the protocol set forth during these experiments meet the requirements for sustainment airfield pavement repair. Furthermore, the successful loading of repairs PHP-1 and PHP-2 suggests that the criteria may also be met when using an untested RAP material. PHP-2 did not receive rejuvenation, and PHP-1 received 2.0 percent CRF, and both repairs passed. Repairs PHP-3 and PHP-4 showed that the rejuvenation and cement stabilization methods evaluated could produce repairs, which meet sustainment repair requirements for airfield pavements. As a result, cement stabilization could be a suitable option for early strength gain for sustainment repair operations.

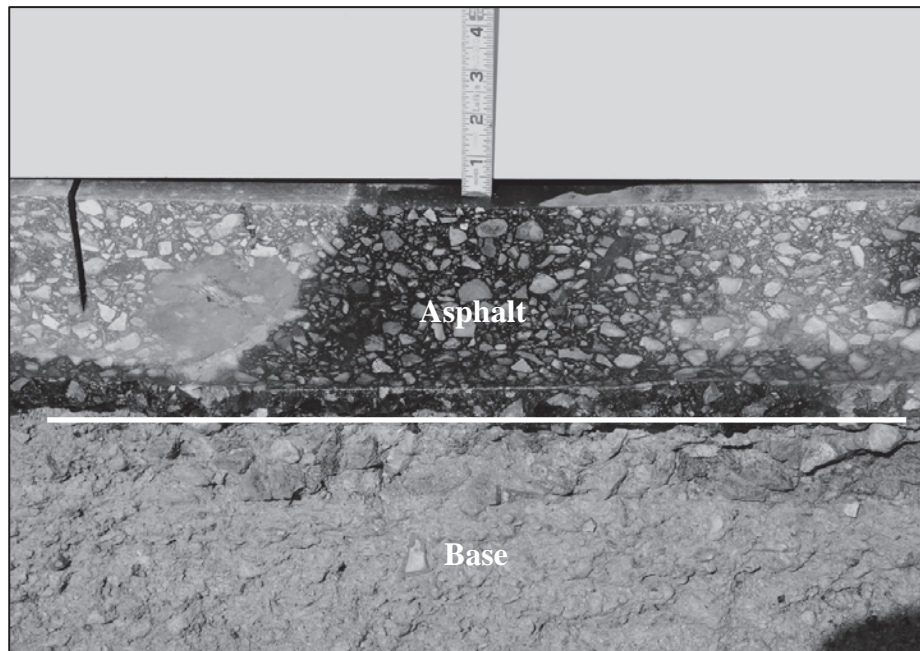
Figures 75 to 76 show the trenched cross-section view of repairs at the ERDC test site after failure. The white lines delineate the boundary between the asphalt and base layers. Shear deformation was not evident in the asphalt pavement, and no deformation was observed at the bottom of the asphalt layer. Therefore, the small amount of deformation observed at the surface of the asphalt layer was attributed to compaction of the asphalt mix. The surrounding asphalt pavement rutted equal to or greater than all the repairs (except for PHP-4) as shown in Figure 78.

Figure 75. Repair PHP-1 trenched cross-section view post traffic.

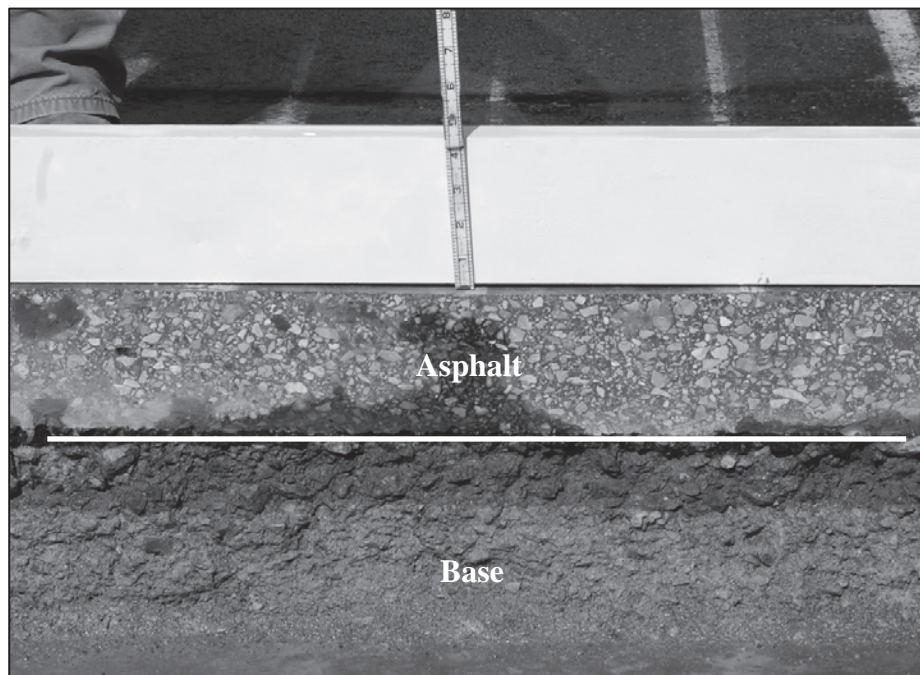
Figure 76. Repair PHP-2 trenched cross-section view post traffic.

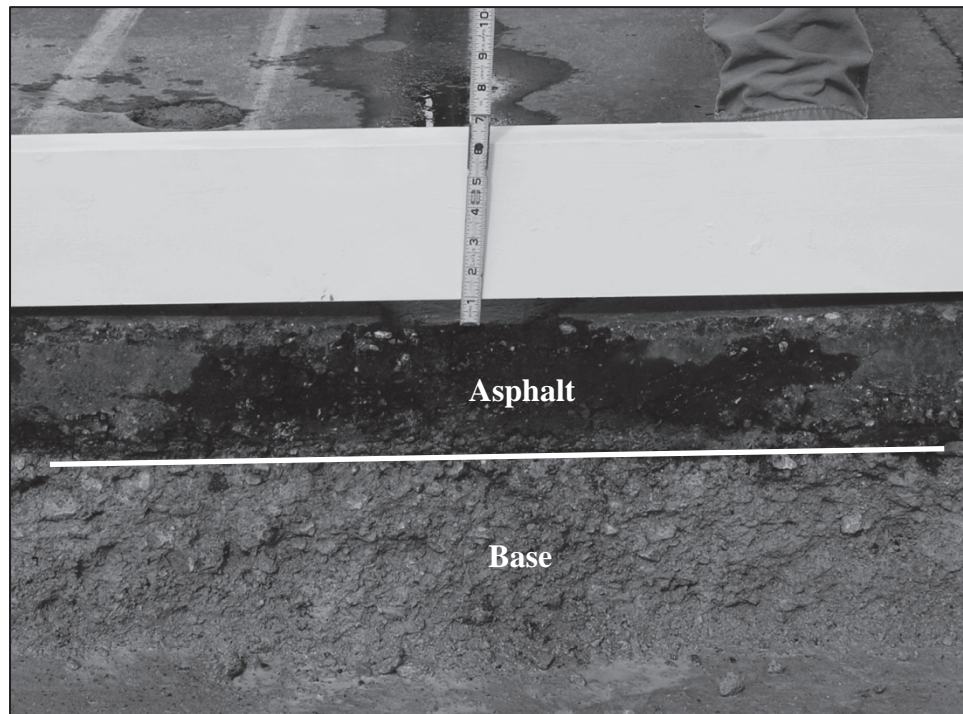
Figure 77. Repair PHP-3 trenched cross-section view post traffic.

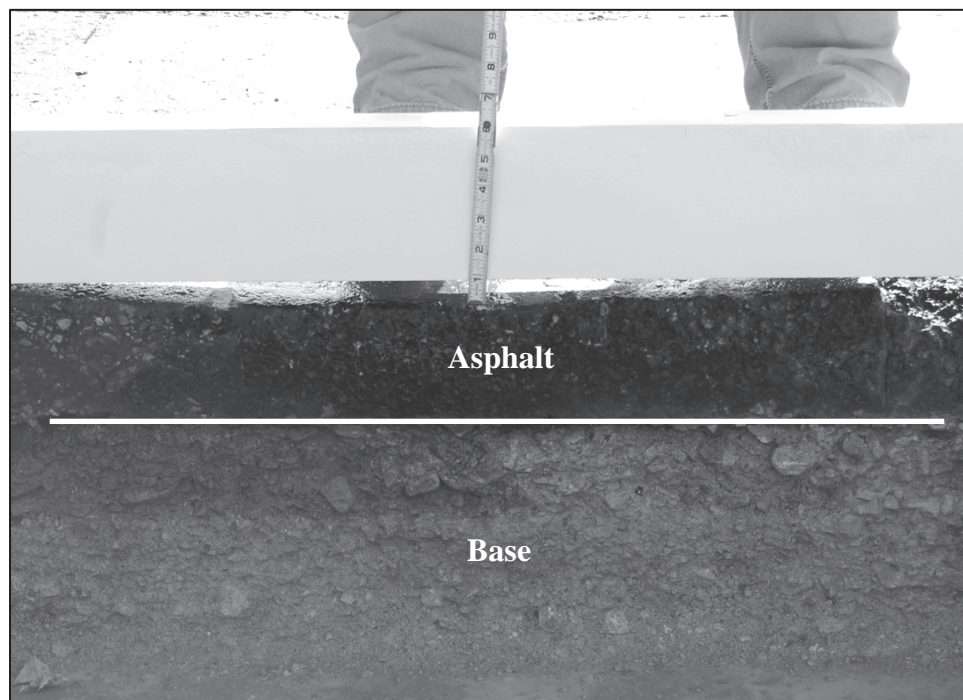
Figure 79. Trenched cross-section view of original asphalt pavement between repairs PHP-1 and PHP-2 post traffic.

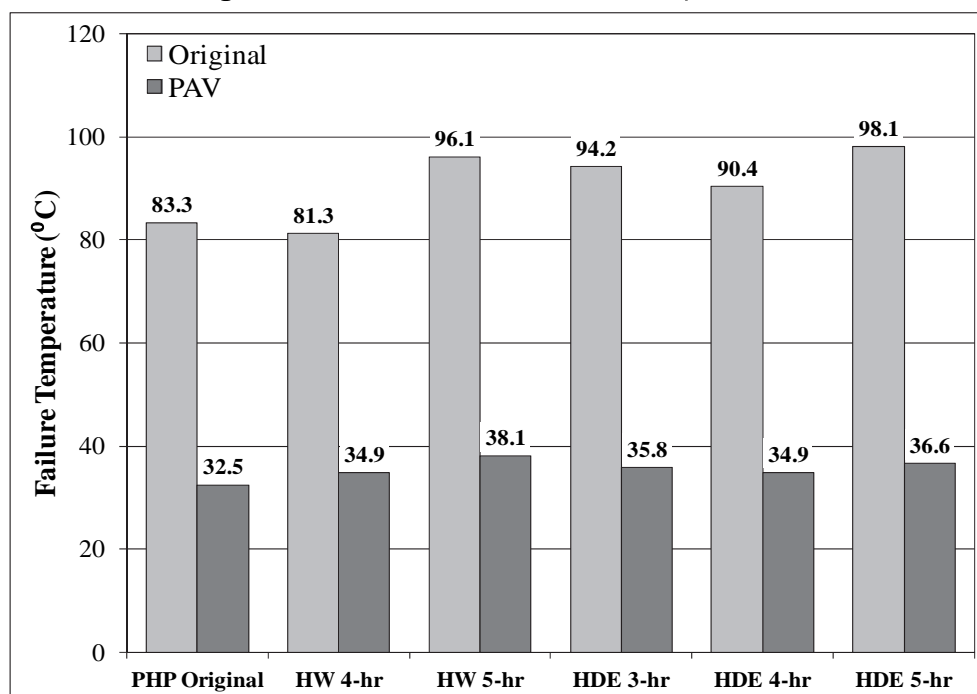
Superpave performance grade binder specifications were used to analyze the DSR data (1.0 kPa minimum for original binder and 5,000 kPa max for PAV aged binder). The failure temperatures from each sample for the original binder and the PAV aged binder are shown in Figure 82, respectively. Higher failure temperatures indicate stiffer binder. As shown, the original binder from the ERDC Test Site and the HW 4-hr specimen failed at similar temperatures, while the HW 5-hr specimen failed at a much higher temperature than the PHP original binder. The failure temperature of the HDE-3-hr specimen was higher than the HDE 4-hr specimen, and both were higher than the original PHP binder. The HDE 5-hr specimen had a noticeably higher failure temperature than the original binder. Since

the HDE 4-hr specimen was aged for a longer period of time, the failure temperature of the HDE 4-hr specimen was expected to be higher than that of the HDE 3-hr specimen. The sampling procedure used is believed to have caused this result, since some of the softer material under the hardened asphalt surface may have been inadvertently obtained during sampling.

Figure 82. Oxidation test binder failure temperatures.

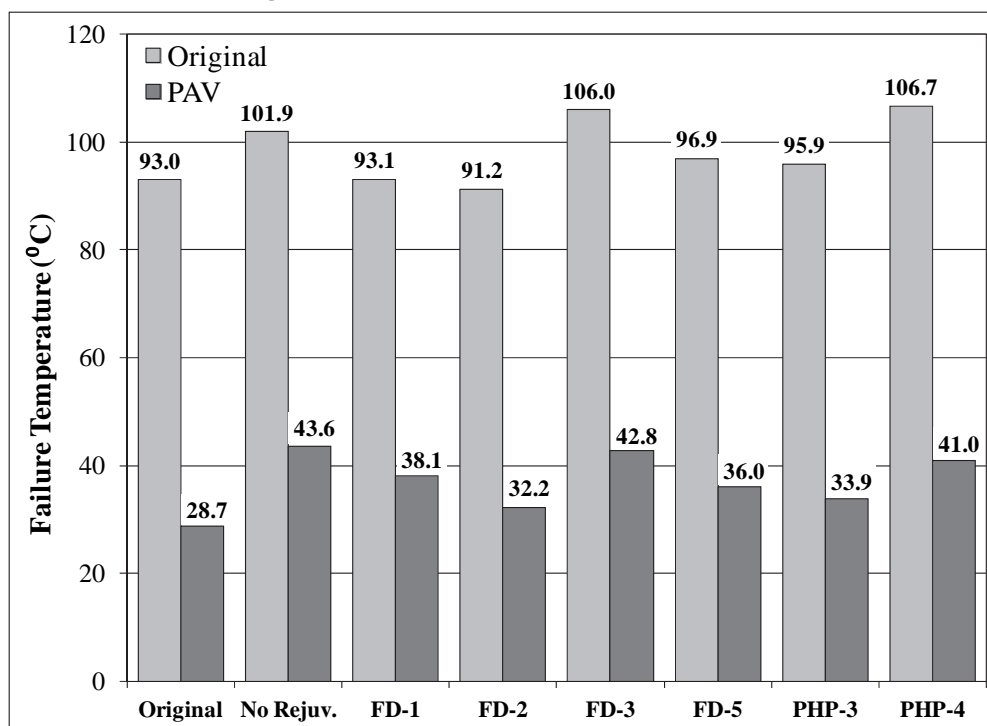
As shown in Figure 83, the binder extracted from the material that was heated but not rejuvenated had a higher failure temperature than the binder extracted from the original pavement. The stiffening of the binder indicated that a considerable amount of oxidation occurred during the heating of the original pavement before removal and rejuvenation. The PAV data suggest that if the removed material is not rejuvenated before compaction, the resulting repair could be more susceptible to performance problems.

Figure 83. Repair binder failure temperatures.

As shown in Figure 83, all original binder specimens extracted from the various repairs exhibited a lower failure temperature than the material that was not rejuvenated, except for FD-3 and PHP-4. Although nearly all of the original binder specimens had a lower failure temperature than the material that was not rejuvenated, only FD-2 and FD-3 showed lower stiffness values than the original pavement binder. However, binder extracted from the 2-in. overlay at the test location was extremely stiff, to the point that no DSR testing could be performed. Although no data could be collected, it is clear that any of the rejuvenated repairs would be an improvement compared to the existing, highly oxidized overlay at the test location. All of the PAV-aged binders had failure temperatures that were higher than the original pavement. The PAV data suggest that the expected long-term performance could be slightly reduced due to the recycling process when compared to the existing asphalt binder's elastic properties. However, as mentioned previously, the recycling process does appear to provide binder flexibility compared to the existing, highly oxidized overlay.
